**Bishop Creek Water Association
Meeting Summary
December 6th, 2016**

BCWA Diversion Structures Needing Repair/Replacement

WEST WEST BISHOP AREA

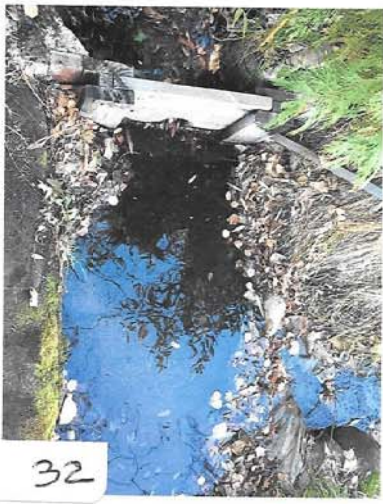
32

18	Line St (No/s) Ditch @ Shepherd Ln (pic #30)	diversions unsecured	locking devices	med.	\$400
19	Line St(No/s) Ditch spill to Bis Ck @ 3875 W Line St (pic #31)	uncontrolled, flow bypassing diversion box	replace sturture & backfill	high	\$900
20	Nelligan Ditch at 299 McLaren Ln(pic #32 & 33)	uncontrolled and dsfunctional	rebuld/replace sturture	med.	\$500
	2 culverts at/under Ranch Rd	culverts are approximately 70 or 80 years old	replacement (2)	low	\$3,600
Noble/Yaney Area					
21	Noble Ditch @ Home St (pic #34)	unsecured	2 locking devices	high	\$400
22	Yaney St So/s ditch at Forest Service (pic #35 & 36)	unsecured, no ability to control diversion	Structure & Locking device	med.	\$1,800
23	Yaney St So/s @ Hanby St (pic #37)	unsecured, no ability to control diversion	Structure & Locking device	med.	\$1,800
	New structures and exsisting key diversion points, including So Indian Hall, & No Indian above west Bishop	inadequate ability to gage and regulate flows	install staff gages (60 @ \$75)	high	\$4,700

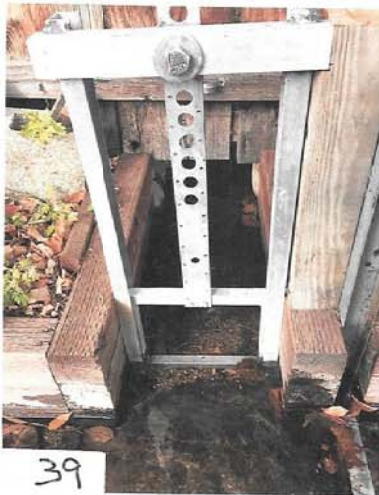
38

Typical replacement div structured (pic 38)				
	Typical locking device (pic 39)
